Upgrading and Replacing Coolers at a Generating Plant

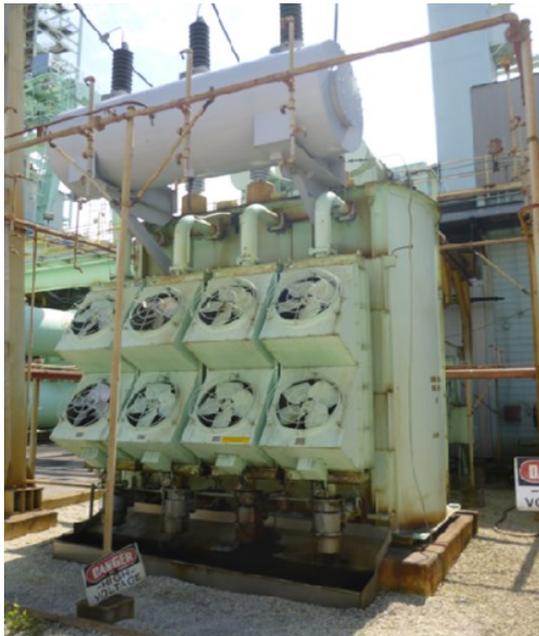
The coal fired generation plant has a 128MVA transformer rated to operate with a top oil temperature of 65°C. The coolers on the transformer had corroded and were leaking oil. The drip pan was continuously filling up and the oil level in the transformer would quickly drop to make the transformer non-operational. Due to the age and extent of the corrosion, the coolers were beyond the scope of repair and had to be replaced.

Before

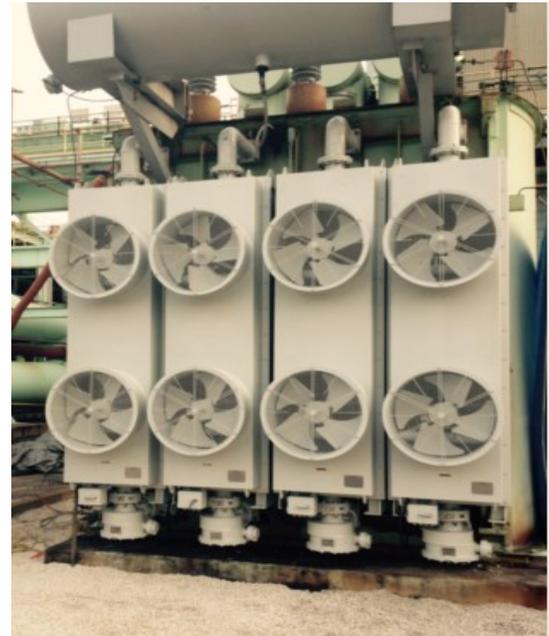
After

The geometric design of the new coolers was similar to the existing coolers but the inherent differences in improved manufacturing over the past several years required a mounting redesign. The mounting hardware was properly designed and modified to ensure the new coolers would be drop in replacements for the existing coolers. After several discussions with the utility and a site visit, the new coolers were built and shipped to the generation plant. The four new coolers, complete with Trantech pumps and oil flow indicators, were swapped out for the old ones in about two days in the constrained work space available around the transformer. After installation of the Trantech coolers, the drip pans were removed and the transformer put back in service.
